**DEPARTMENT OF TRANSPORTATION****DIVISION OF ENGINEERING SERVICES**

Contract #: 04-0120F4Cty: SF/ALA Rte: 80 PM: 13.2/13.9File #: 69.28**WELDING INSPECTION REPORT****Resident Engineer:**Siegenthaler, Peter**Address:** 333 Burma Road**City:** Oakland, CA 94607**Report No:** WIR-018192**Date Inspected:** 16-Nov-2010**Project Name:** SAS Superstructure**OSM Arrival Time:** 700**Prime Contractor:** American Bridge/Fluor Enterprises, a JV**OSM Departure Time:** 1900**Contractor:** Zhenhua Port Machinery Company, Ltd (ZPMC), Changxing Island **Location:** Shanghai, China**CWI Name:** An Qing Xiang**CWI Present:** Yes No**Inspected CWI report:** Yes No N/A**Rod Oven in Use:** Yes No N/A**Electrode to specification:** Yes No N/A**Weld Procedures Followed:** Yes No N/A**Qualified Welders:** Yes No N/A**Verified Joint Fit-up:** Yes No N/A**Approved Drawings:** Yes No N/A**Approved WPS:** Yes No N/A**Delayed / Cancelled:** Yes No N/A**Bridge No:** 34-0006**Component:** Orthotropic Box Girder( OBG)**Summary of Items Observed:**

OBG TRIAL ASSEMBLY YARD

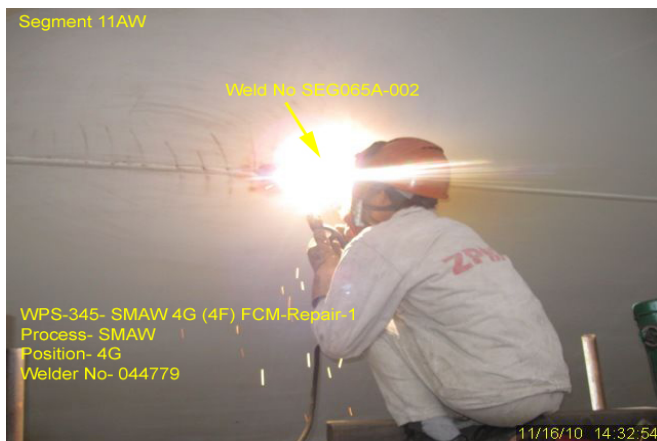
**WELDING:****Segment 11AW**

This QA Inspector observed ZPMC qualified welding personnel identified as 044779 perform Shielded Metal Arc Welding (SMAW), weld joint identified as SEG065A-002; located On Orthotropic Box Girder (OBG) Side Plate to Side Plate Longitudinal Splice CJP Weld. The Welding Repair Report (WRR) was B-WR16838. ZPMC QC is identified as Mr. Zhang Qiang. The welding parameters measured using QC's calibrated instrument appeared to be in general compliance with applicable WPS-345-SMAW 4G (4F) FCM-Repair-1. See attached photo for further details.

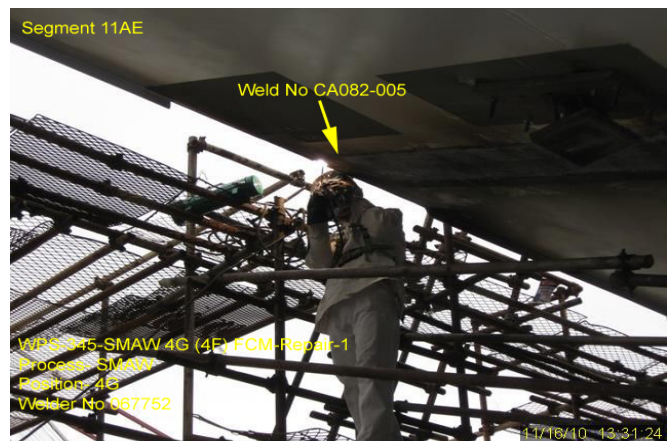
**Segment 11AE**

This QA Inspector observed ZPMC qualified welding personnel identified as 067752 perform Shielded Metal Arc Welding (SMAW), weld joint identified as CA082-005; located On Orthotropic Box Girder (OBG) Side Plate to Edge Plate CJP Weld. The Welding Repair Report (WRR) was B-WR17064. ZPMC QC is identified as Mr. Wang Li Yang. The welding parameters measured using QC's calibrated instrument appeared to be in general compliance with applicable WPS-345-SMAW 4G (4F) FCM-Repair-1. See attached photo for further details.
